UNDERWATER BRIDGE INSPECTION REPORT

STRUCTURE NO. 02526
CSAH NO. 7
OVER THE
RUM RIVER
DISTRICT 5 - ANOKA COUNTY

PREPARED FOR THE
MINNESOTA DEPARTMENT OF TRANSPORTATION
BY
COLLINS ENGINEERS, INC.
JOB NO. 5221 (CEI 105)

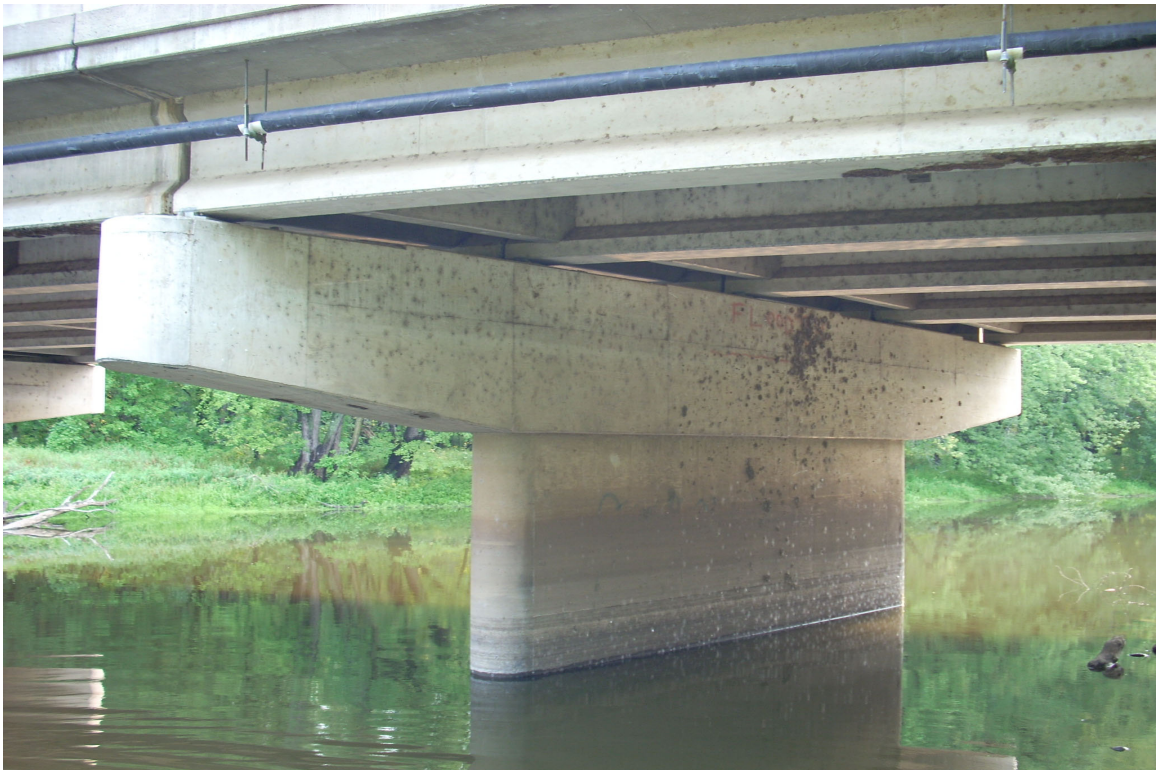
Photograph 2. View of Pier 1, Looking Northeast.

- (C) A band of light scaling was observed from the waterline up 3 feet with a maximum penetration of 1/8 inch on Piers 1 and 2.
- (D) Top of footing was exposed at 5.8 feet below the waterline from the upstream nose to 8 feet downstream of the upstream nose along the north face of Pier 1 with no vertical face exposure.

- (A) Consideration can be given to the removal of timber debris during normal maintenance operations and the footing exposure at Pier 1 should be monitored during future inspections.
- (B) Reinspect the submerged substructure units at the normal maximum recommended (NBIS) interval of five (5) years.

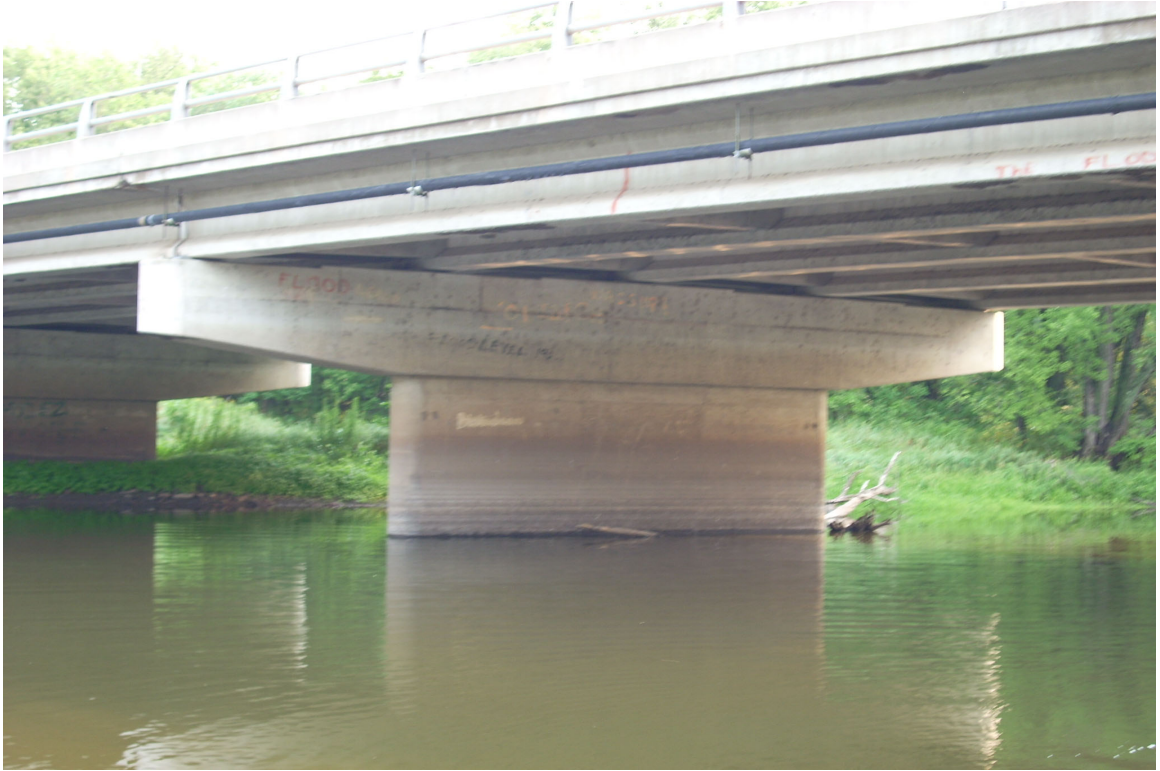
Photograph 3. View of Pier 2, Looking Northeast.

- (B) A moderate accumulation of 18-inch-diameter and smaller timber debris was observed at Pier 2 from the downstream quarter point of the south face, around the upstream nose to the downstream quarter point of the north face. The timber debris extended from the channel bottom to the waterline and up to 30 feet out from the upstream nose of the pier. A light accumulation of up to 4-inch-diameter timber debris extended from the channel bottom up to 2 feet by 3 feet wide and 3 feet long at the upstream end of Pier 1.

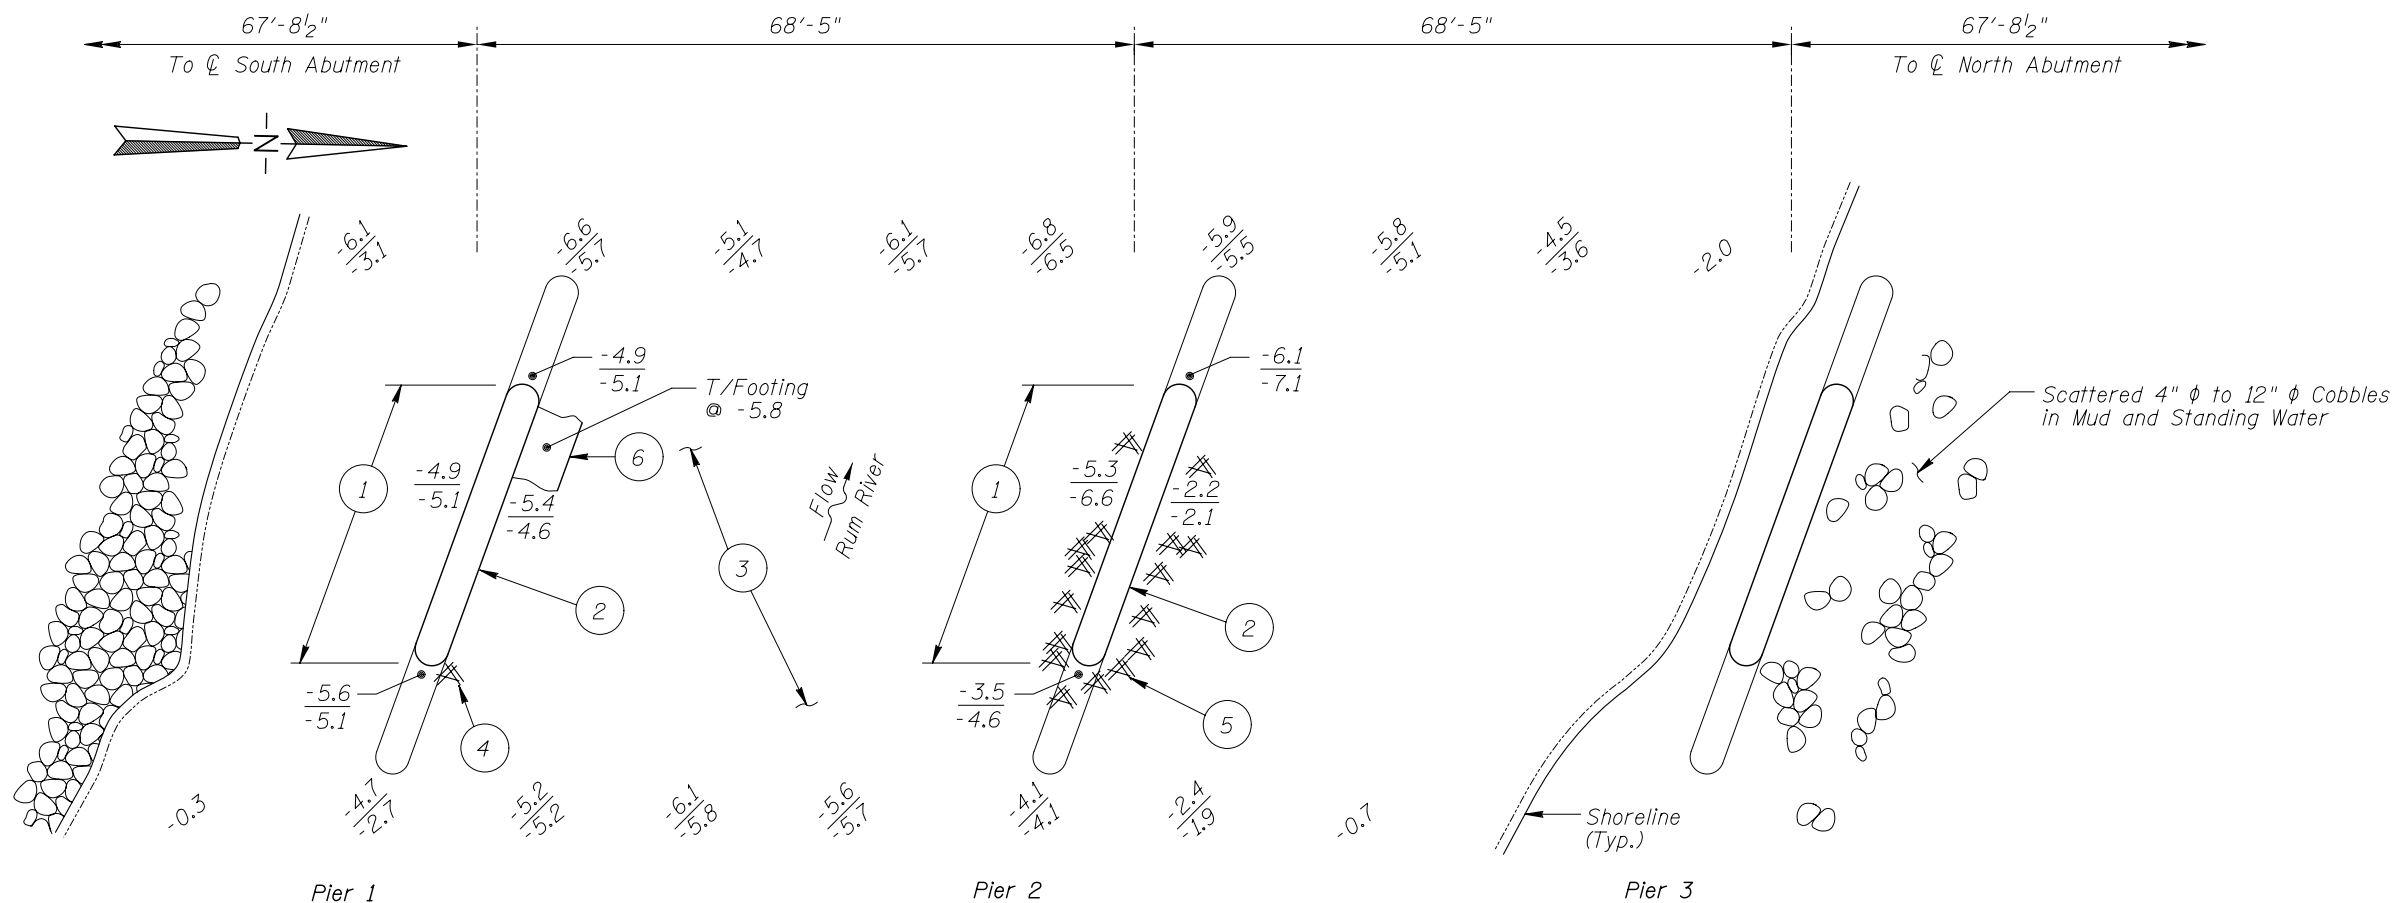
INSPECTION AND SOUNDING PLAN

- 1 Overall, the concrete of the piers was in smooth, sound condition with no defects of structural significance.
- 2 A band of light scaling was observed on Piers 1 and 2 from the waterline up 3 feet with a maximum penetration of 1/8 inch.

- 3 The channel bottom consisted of firm sand with 2 to 3 inches of probe rod penetration and 12-inch-diameter riprap located at the upstream noses of Piers 1 and 2 and along the south face of Pier 1.

- 4 Light accumulation of debris consisting of branches up to 4 inches from the channel bottom up 2 feet by 3 feet wide and 3 feet long at the upstream end of Pier 1.

- 5 A moderate accumulation of timber debris 18-inch-diameter or smaller consisting of logs and branches was observed from the downstream 1/4 point of south face, around the upstream nose, to the downstream 1/4 point of the north face. The debris extended from the channel bottom to the waterline and up to 5 feet off the pier faces and up to 30 feet off of the pier nose.

- 6 Top of footing was exposed at 5.8 feet below the waterline from the upstream nose to 8 feet downstream of the upstream nose along the north face of Pier 1 with no vertical exposure.
